**From:** [BDC Lgoima](#)  
**To:** [REDACTED]  
**Subject:** Official Information Request for Stockton Mine Monitoring - RC Compliance Ref: OIA 121/24  
**Date:** Thursday, 7 November 2024 10:28:03 am  
**Attachments:** [2022 AP File Note.pdf](#)  
[Cypress Road Construction Consent Boundary Breach April 2024 .pdf](#)  
[FY22 Cypress Environmental Monitoring Report.pdf](#)  
[Fwd Memorandum Subsidence in Cypress Mining Area.msg](#)

# CYPRESS MINE

This is the thirteenth Cypress Environmental Monitoring Report, provided under condition A17 of the Cypress Mine resource consents. The report is structured according to condition A17.3 of resource consents RC03175 and RC03164.

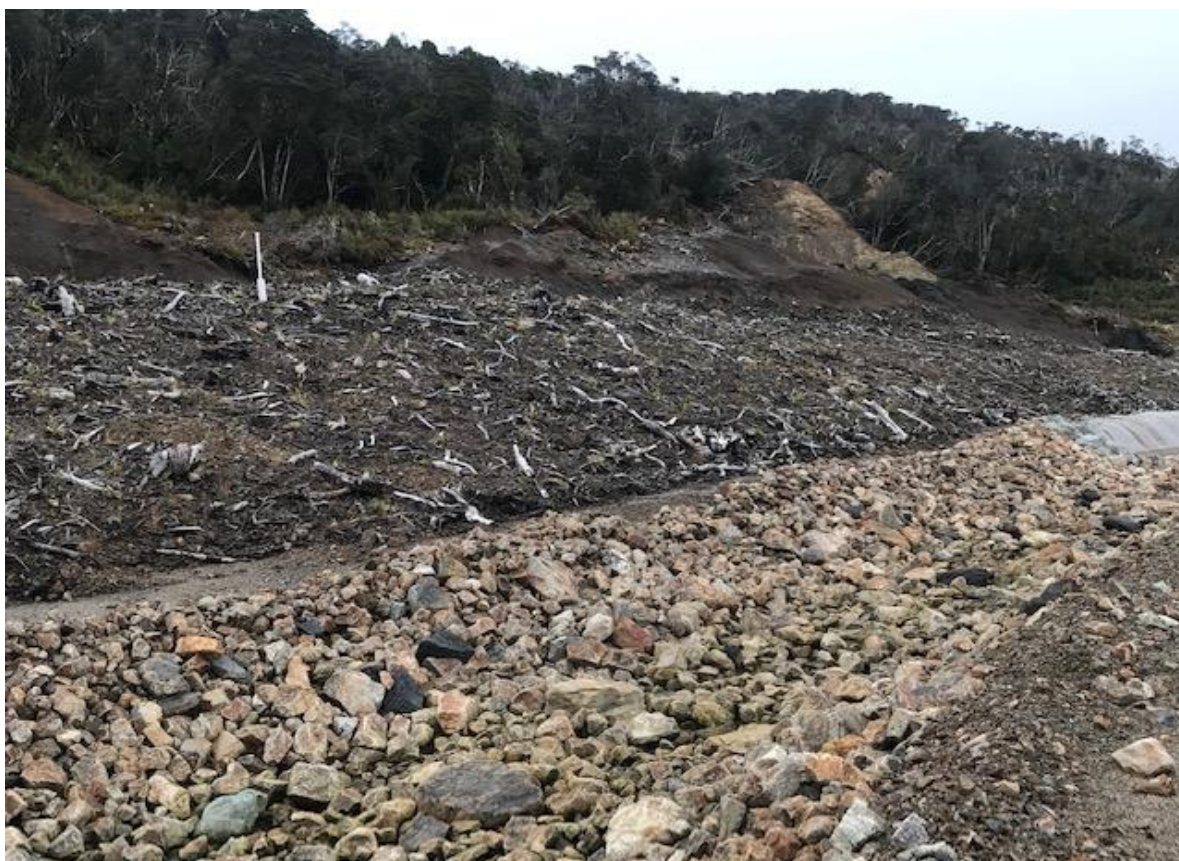
Planted area below Pushback 0 of around 0.5ha. This is the only rehab completed to date due to the active work areas.

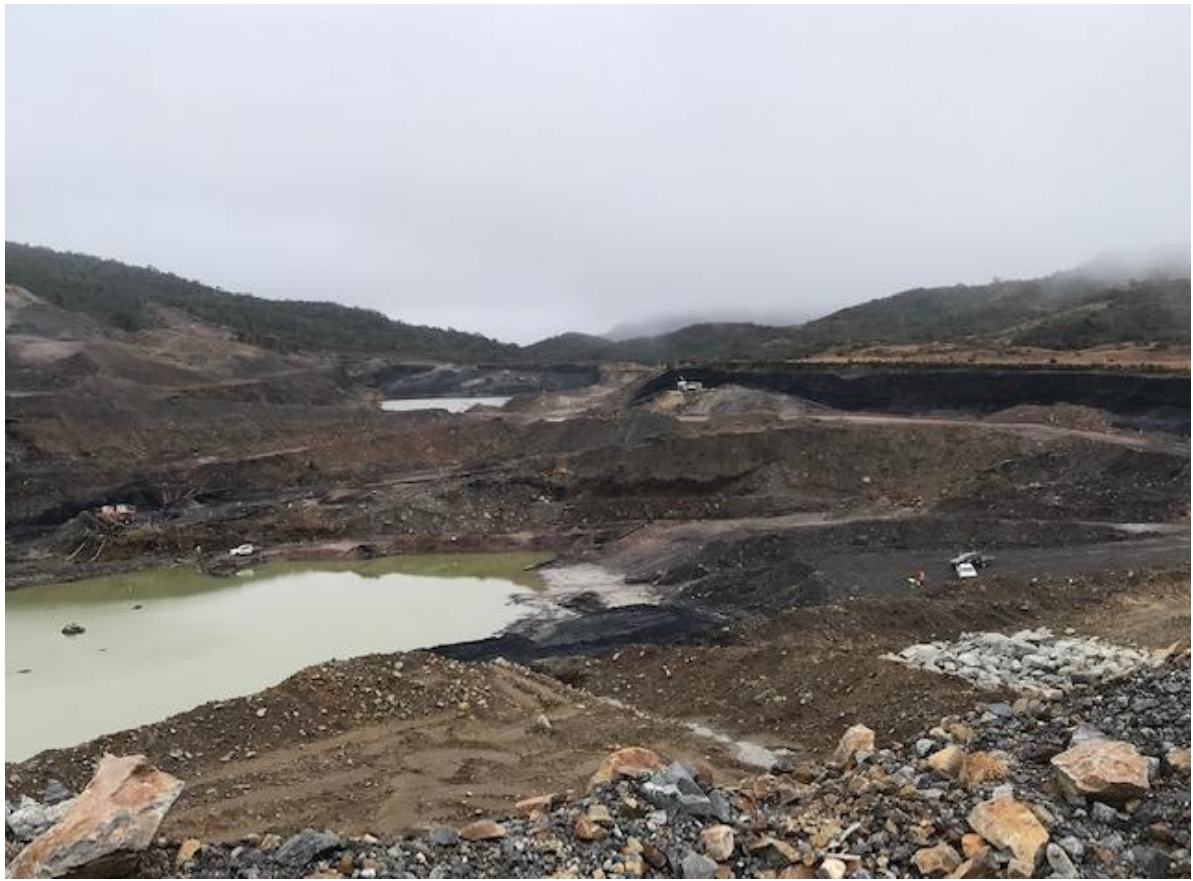
View of the northern box cut and pushbacks above.

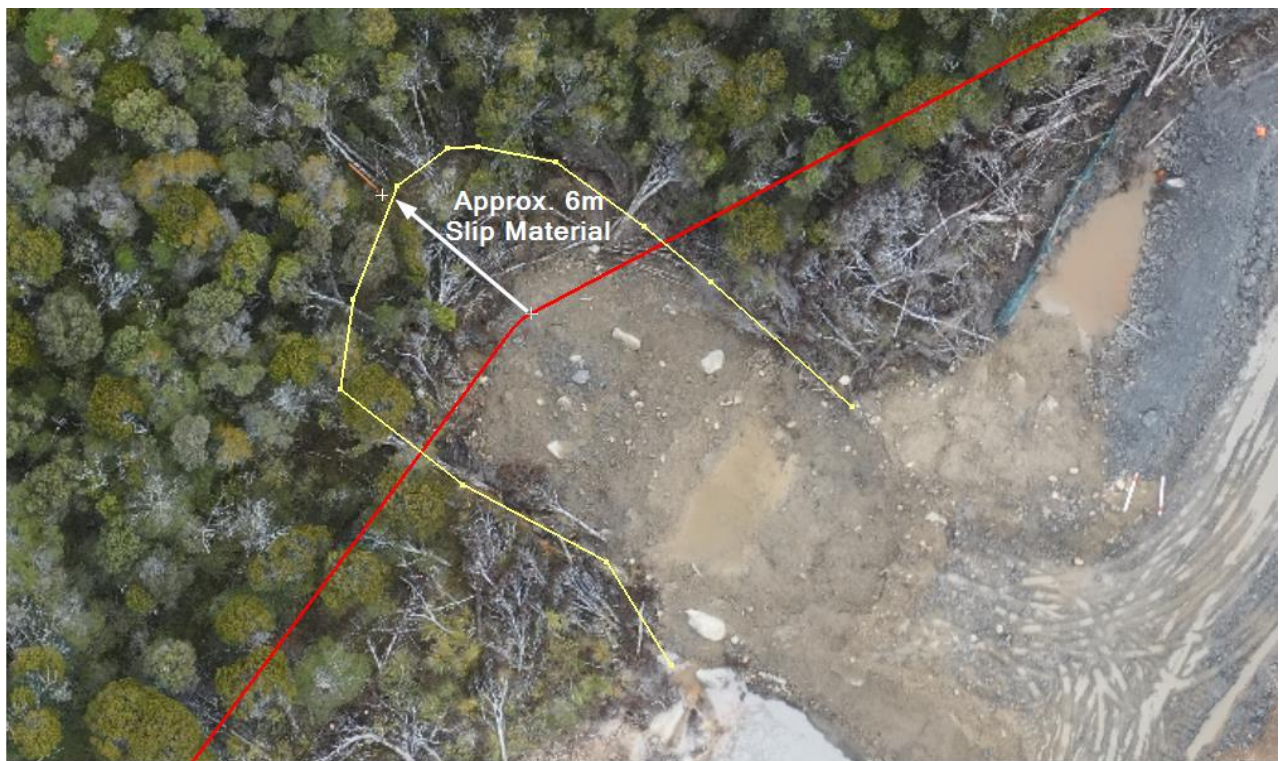
- Refer to Figures 1 and 2 below for location of the failure outside of the consent boundary.
- Digger activity was well within the consent boundary. No intentional nor unnecessary risks were undertaken and hence were in keeping with consent conditions A1.2 and A1.3. The landslide could not have been foreseen.
- Works ceased immediately as per Bathurst health and safety and environmental compliance priorities and protocols.

**Figure 1:** Red line is consent boundary. + is consent boundary peg, original and moved. Yellow line marks slip extent.

- Immediate work was undertaken to revise work activity plans to a safer position by removing the need for a bund by pushing into the hillside at a reduced angle. A new plan was issued to contractors on 2<sup>nd</sup> April with clear instructions to ensure the safe execution of the revised plan, adhering to all relevant site operating standards and environmental controls with an immediate 'If in doubt, stop work' clause and communication with the Technical Team. Exclusion zones were loaded into all machines for reference and consultation. This is in keeping with consent conditions A1.2 and A1.3.

- There has been no activity to remediate the slip area outside of the council boundary. This decision has been made to avoid releasing more slip material downslope and compromise sediment controls and subsequent effects on waterways. This aligns with Consent condition A11.2 which outlines what the Construction and Earthworks Management Plan shall provide for.

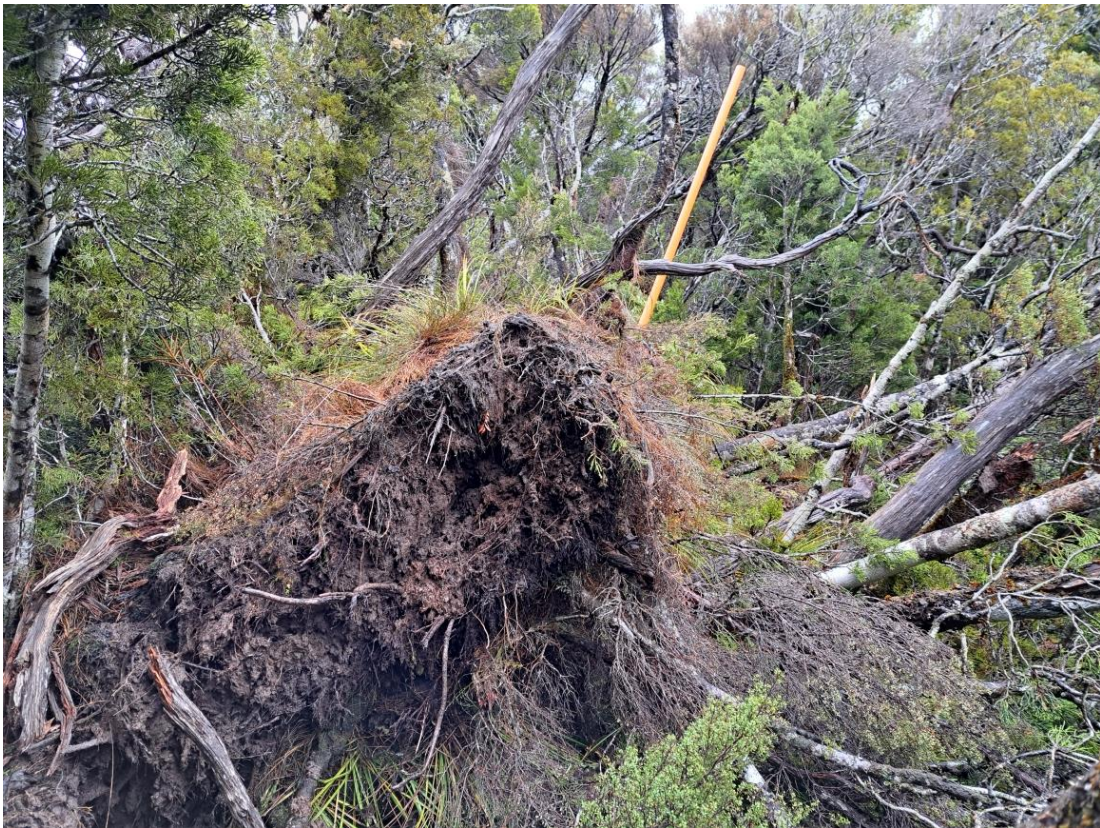
- A drone survey from the 4<sup>th</sup> April was transposed by the water engineer onto water designs first picked up the extent of the slip and potential consent boundary encroachment. A subsequent site visit undertaken on 12<sup>th</sup> April by Geotechnical Service and Environment and Community Team staff confirmed slip movement across the consent boundary.
- The disturbance as it stands is a bow-wave of topsoil and vegetation debris with the consent boundary marker still standing in-situ (as per figure 1). There is a pile of weathered rock and silt material behind this vegetation (Figure 1 yellow line) which has extended past the consent boundary.
- Refer to site investigation images below (12<sup>th</sup> April 2024).

**Figure 3:** Looking north to south across the leading edge of the slip debris with the consent boundary marker clearly visible.

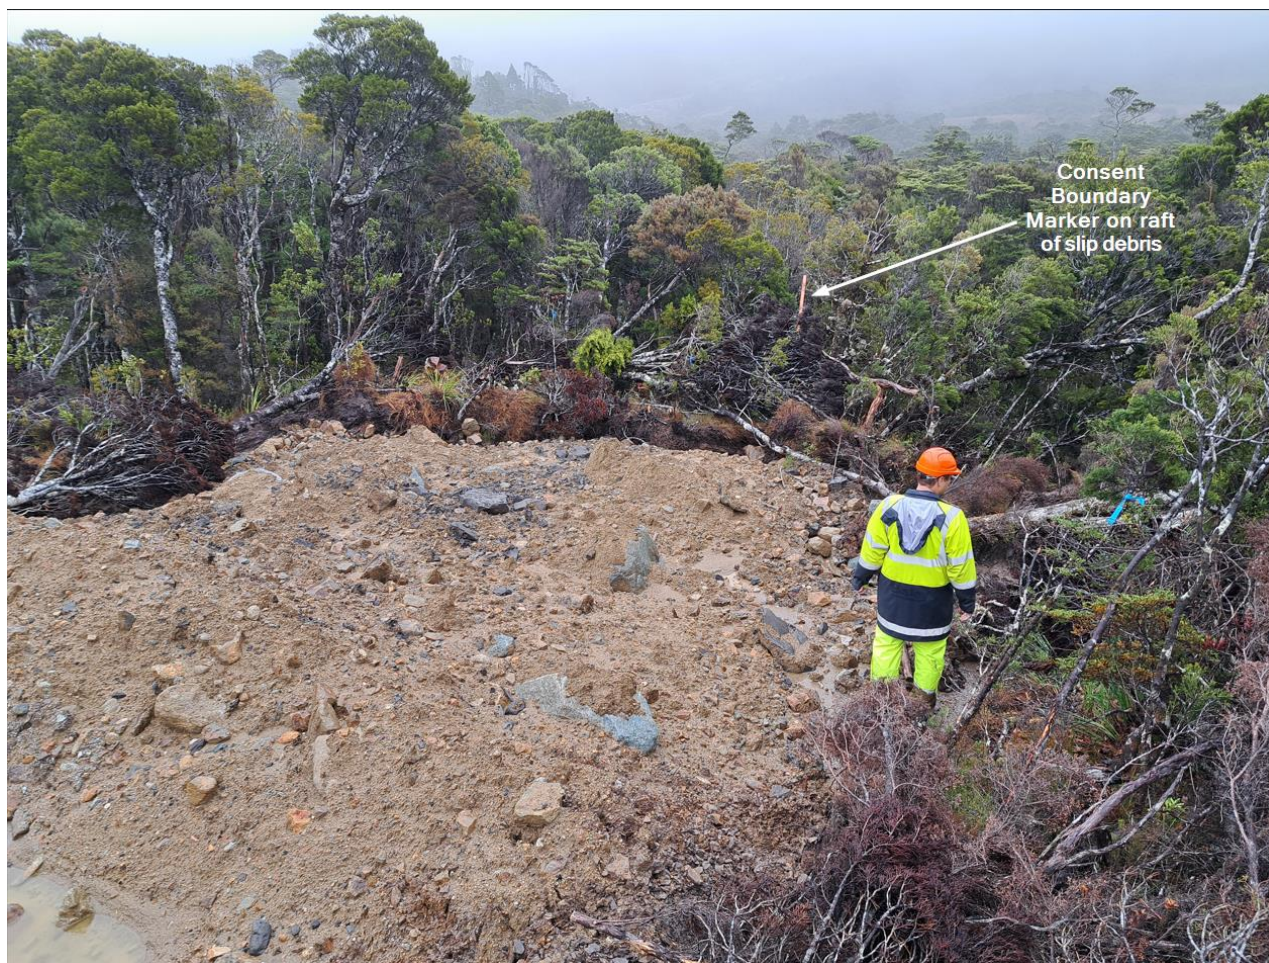
**Figure 4:** Weathered rock/mud backed-up behind the leading edge of the slip.

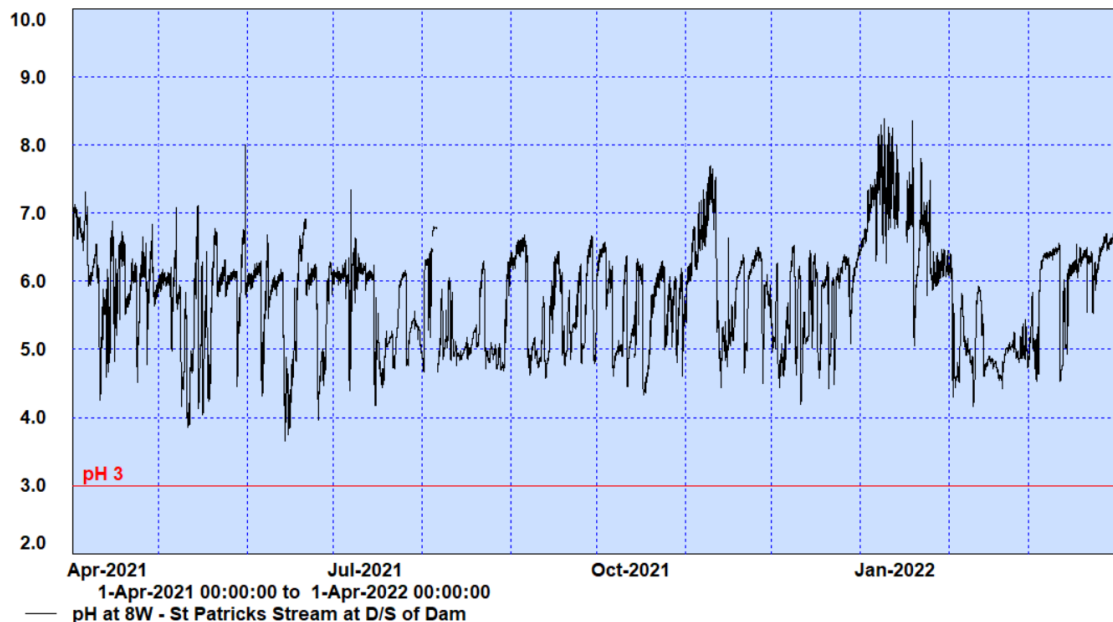
**Figure 3.1.2: 8W sensor pH, 1 April 2021 – 31 March 2022.**

The quality of the St Pats dam water has been greatly improved with water treatment beginning July 2020; so that pH at 8W was > 3 100% of the time for RY2021/22, (and > 4.5 97.5% of the time)

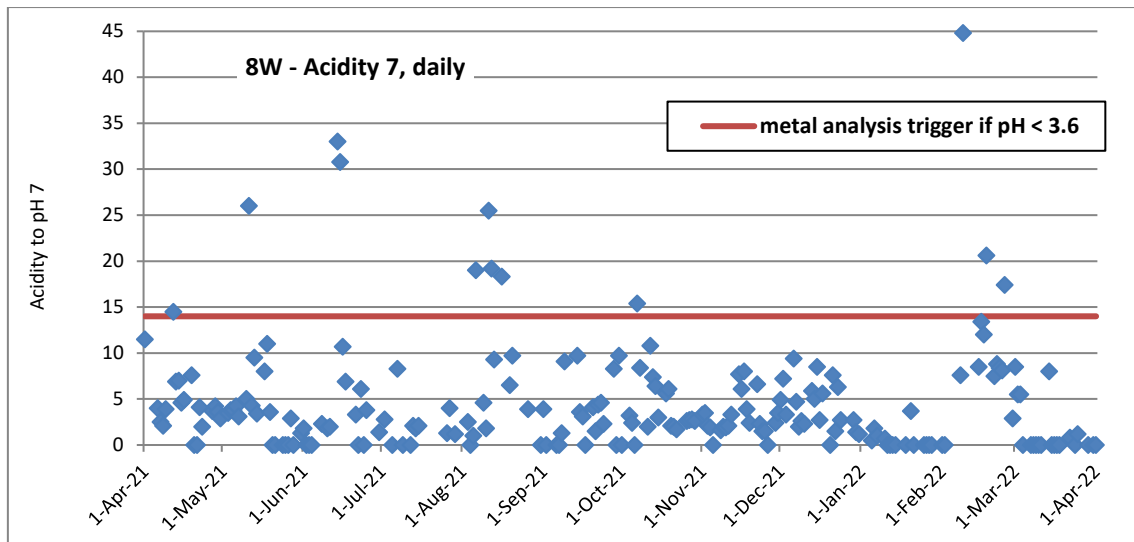
Figures 3.1.6 and 3.1.7 present the daily pH and Acidity (7) sample results for 2021/22 reporting year. Sampled pH did not fall below 3.6 during the reporting year, so no metals sampling in relation to this condition (B8.9) was required.

**Figure 3.1.6: 8W daily pH, 1 April 2021 – 31 March 2022**

**Figure 3.1.7: 8W daily acidity, 1 April 2021 – 31 March 2022**

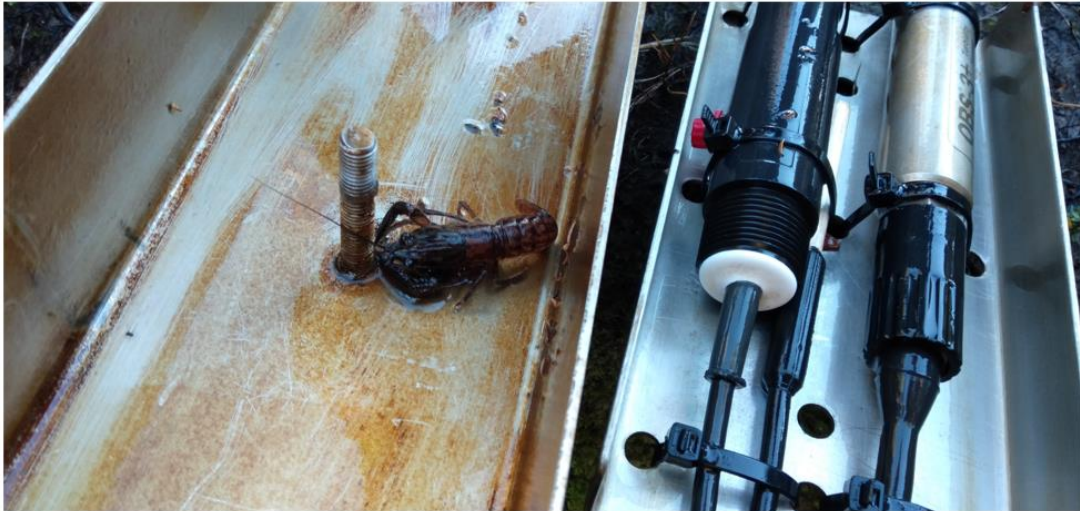
**Figure 3.1.15: Koura within casing of water quality instruments at 7W – 7 April 2022**
